Manhole Inspection Summary

Manhole # S27M__033MH

Insp Date: **5/8/08 2:16 PM**

Location Address: **637 Nanticoke St**

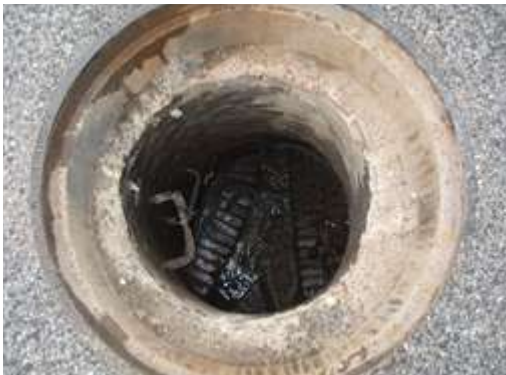
top view pic 2

bh - frame is too big for chimney

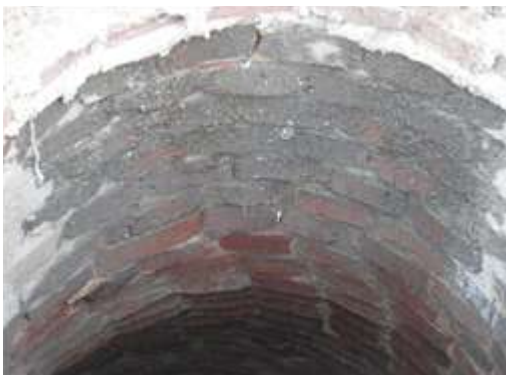
Defect 4

Infiltration: ☐ None ☒ **Joint** ☐ Cracks ☒ **Mortar** ☐ Roots ☒ **Wall**

chimney flow wall, mortar

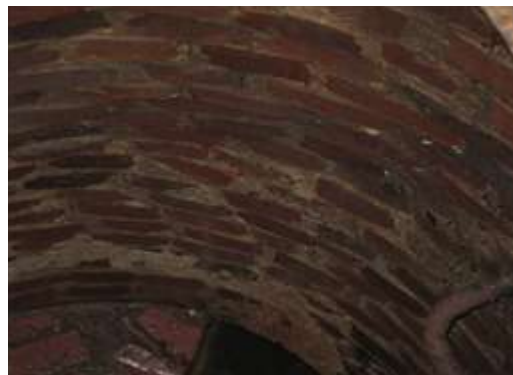
Defect 3

Infiltration: ☐ None ☐ Joint ☐ Cracks ☒ **Mortar** ☐ Roots ☒ **Wall**

barrel and corbel flow wall, mortar

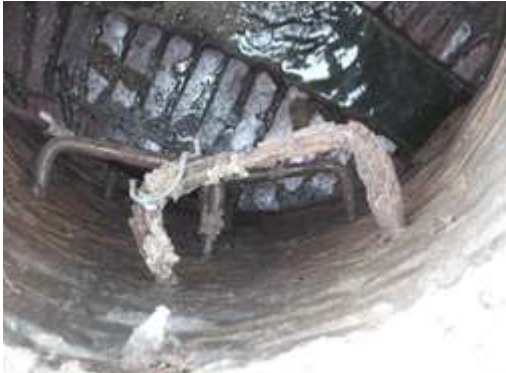
Defect 1

Count: **4** Missing: **1** ☒ **Corroded**

Corroded steps

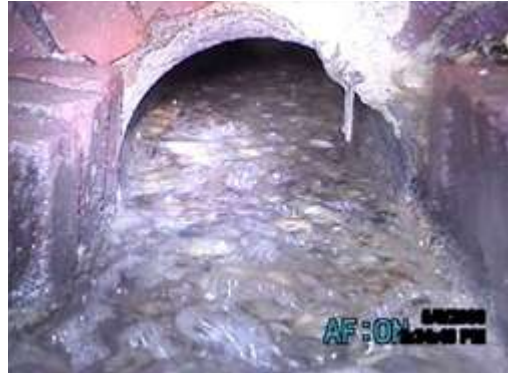
Defect 2

Condition: ☐ Sound ☐ Cracked ☐ Root Intrusion ☐ Deteriorated ☐ Leaks ☒ **Debris**

channel cond debris
